United States General Accounting Office

October 1997

DEFENSE INVENTORY

Management of Surplus Usable Aircraft Parts Can Be Improved

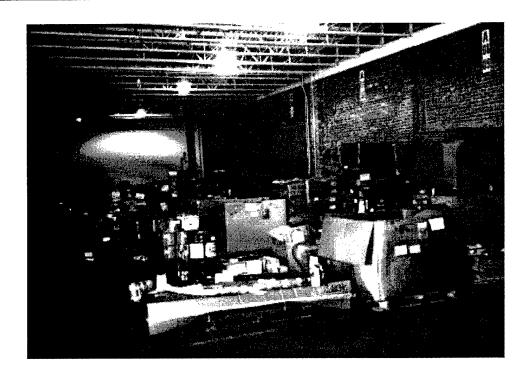
Figure 2: Cobra Helicopter Parts Stored at Corpus Christi DRMO

At the Corpus Christi DRMO, we observed quantities of 157 different usable parts for the AH-1 Cobra helicopter scheduled for destruction (see fig. 2). Specifically, we noted that there was a total of 1,972 usable, mostly new, helicopter parts in a DRMO warehouse. The parts originally cost \$6.9 million. According to the DRMO Chief, these parts were to be destroyed beginning May 3, 1997, to free up storage space. We contacted the Defense Reutilization and Marketing Service and advised it of our concern with the scheduled destruction because the assigned demilitarization codes indicated no military technology was associated with 155 of the 157 different parts and because there were sufficient amounts of warehouse storage space for the parts.

Defense Reutilization and Marketing Service officials said that in February 1996, they placed a prohibition against selling Cobra parts at DRMOS because the Army-assigned demilitarization codes were inaccurate. The property disposal specialist responsible for the prohibition said the Army planned to review and validate the demilitarization codes for the Cobra helicopter parts and he wanted to be sure the codes were accurate before proceeding with a sale or destruction action. He said the Army had not completed its demilitarization code review. The specialist said he also instructed the DRMOS to destroy the parts if they started experiencing a storage impact. After a meeting with the Chief of the Corpus Christi DRMO, the Defense Reutilization and Marketing Service issued a memorandum directing the DRMOS not to destroy any Cobra parts unless they are in a scrap condition and to hold usable parts in storage until the Army completes the demilitarization code review.

Army Aviation and Troop Command officials who are responsible for reviewing and validating demilitarization codes for Cobra helicopter parts told us they were waiting to complete the demilitarization code review until after Army headquarters makes a decision on whether or not to sell disarmed, surplus Cobra helicopters to the public for use in such purposes as fighting forest fires. In our opinion, accurate code assignments are required regardless of whether the helicopters are sold to the public.

- Require the Army to complete its validation of the demilitarization codes assigned to Cobra helicopter parts so commercial-type parts and nonsignificant military unique parts can be sold.

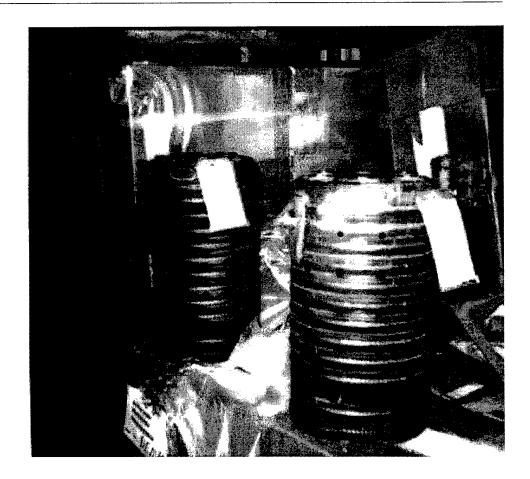
Figure II.1: Engine Combustion Chamber

Parts Assigned Inaccurate Demilitarization Codes The Air Force decided that 184 TF-33 engine combustion chambers (Stock No. 2840008285214RV) (see fig. II.1) used on the KC-135 aircraft were surplus and sent them to the Oklahoma City DRMO. The parts originally cost \$452,352. On April 15, 1997, the DRMO destroyed the 184 parts, although the parts were repairable. The DRMO destroyed the parts because the Air Force had assigned a demilitarization code to the parts requiring total destruction to protect military technology. The DRMO estimated that it spent \$211 to destroy the parts and sold them as scrap for \$3,450. After we pointed out that this was a commercial-type item, the Air Force equipment specialist said the assigned demilitarization code was incorrect because the parts contained no military technology. As a result, the DRMO destroyed parts that the private sector could have used. The equipment specialist corrected the demilitarization code.

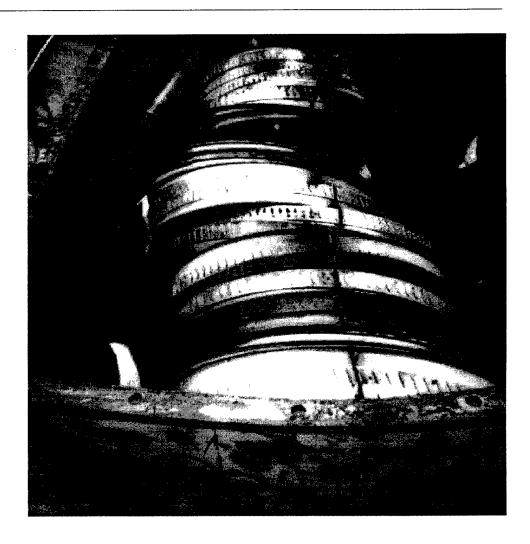
Figure II.2: Nozzle Rings

On April 9, 1997, we observed the destruction with a cutting torch of 20 nozzle rings (Stock No. 2840011611133RV) (see fig. II.2) used on the KC-135 aircraft engine. These parts originally cost \$94,400. The Oklahoma City destroyed the parts because the Air Force had assigned a demilitarization code that required total destruction to protect military technology. According to the equipment specialist, the Air Force replaced the parts with a newer version. He said that the parts sent to the draw, although usable, were no longer needed by the Air Force. After we pointed out that this was a commercial-type item, the equipment specialist said the assigned demilitarization code was incorrect because the part contained no military technology. He also said the destroyed parts were usable on commercial Boeing 707 aircraft in the private sector. As a result, the destroyed parts that the private sector could have purchased. The equipment specialist corrected the demilitarization code.

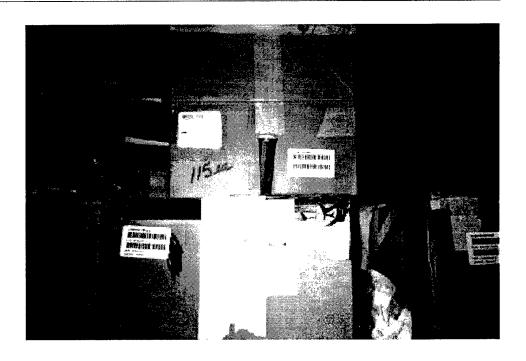
Figure II.3: Turbine Rotor Blades in Manufacturer's Original Packaging

helicopter for disposal. Since the Army had assigned demilitarization code F to the parts, indicating that they had flight safety implications, the DRMO requested disposition instructions from the Army Aviation and Troop Command. The Command instructed the DRMO to destroy the part unless it was (1) unused, (2) in serviceable condition, (3) physically marked with the manufacturer's code, and (4) in the manufacturer's original packaging. The DRMO decided that the parts met this exception and offered them for sale. DRMO records showed that the turbine rotor blades were sold in a lot with another turbine rotor blade for \$13,796.
